Device TC22x/TC21x
Marking/Step ES-AC, AC
Package see Data Sheet

10310AERRA

This Errata Sheet describes the deviations from the current user documentation.

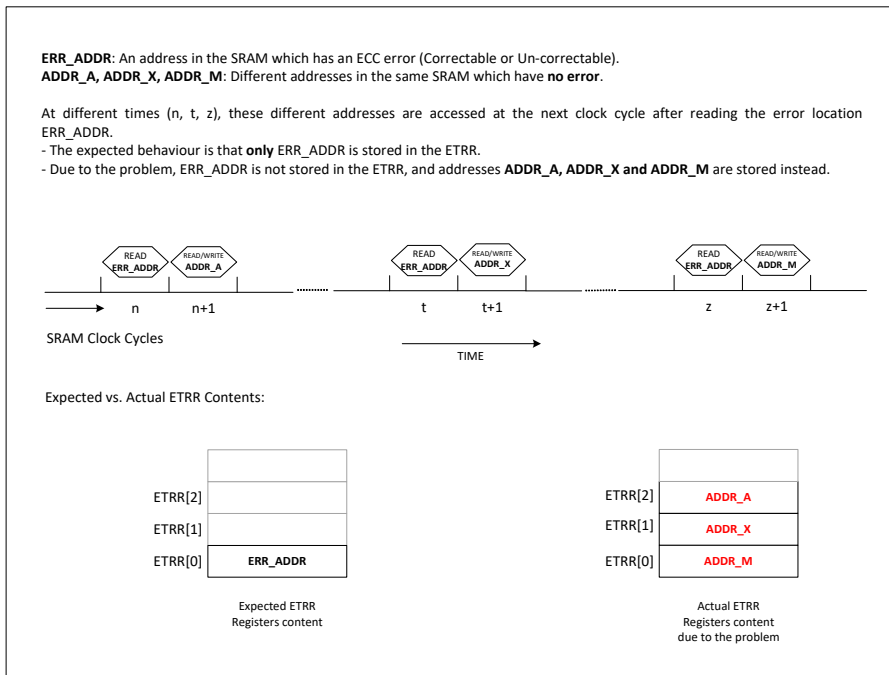
Figure 1 Example sequence showing how registers ETRRx may be filled with “Error Free” addresses

When such a consecutive access sequence (read from ERR_ADDR followed by read/write of different address(es)) happens multiple times, registers ETRRx

are filled with addresses that have actually no error – and the SRAM address which actually has an error is not stored indeed. **Figure 1** shows such an example scenario.

The consequence of the scenario explained in **Figure 1** is that a single error in the SRAM – example just one correctable error at a location ERR_ADDR – can result in registers ETRRx getting filled with fault-free address, and thus potentially even triggering an ETRR overflow.

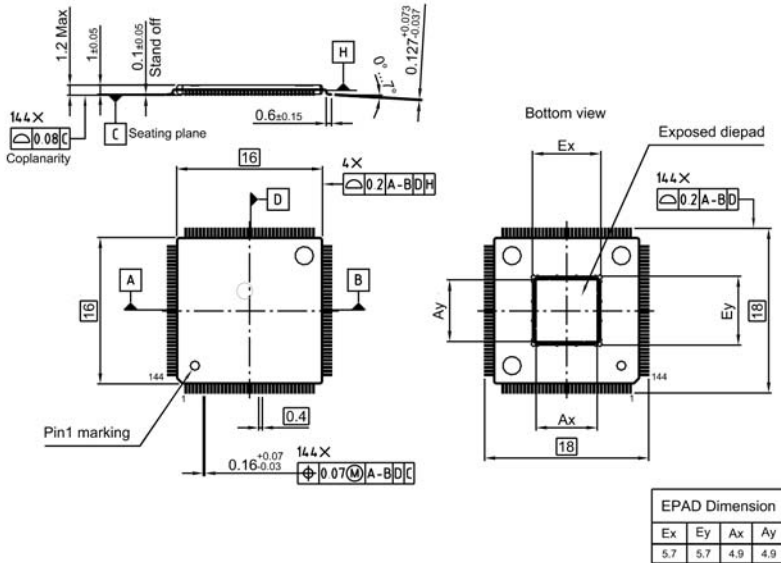
Figure 8 Package Outlines TQFP-144 for TC22x/TC21x

Note: For the exposed pad of the TQFP-144 package of the TC22x/TC21x, structural corner protrusions have to be considered for purposes of system design and integration with a maximum boundary of 6.2 mm.

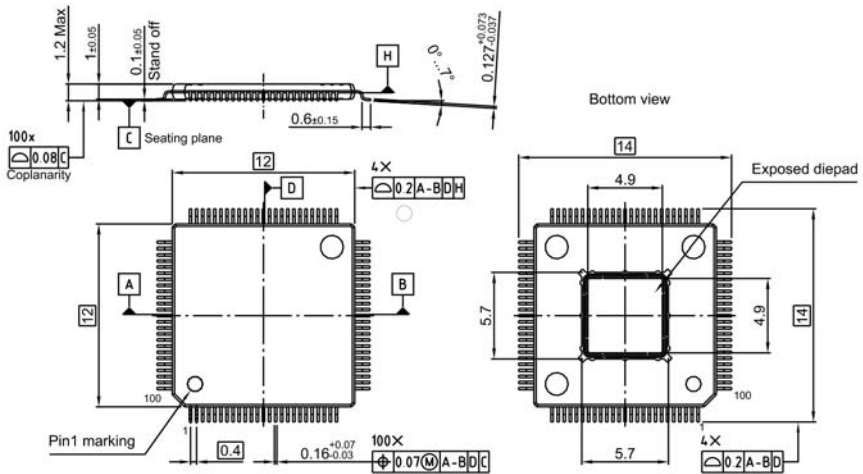
Figure 9 Package Outlines TQFP-100 for TC22x/TC21x

Note: For the exposed pad of the TQFP-100 package of the TC22x/TC21x, structural corner protrusions have to be considered for purposes of system design and integration with a maximum boundary of 6.3 mm.

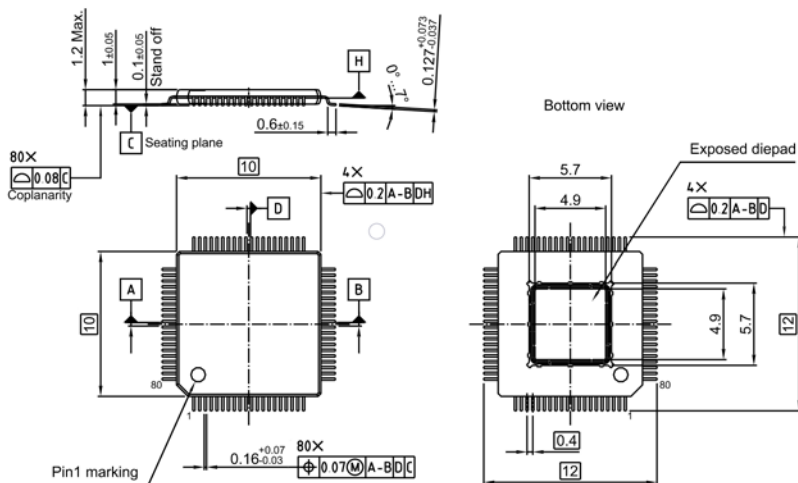
Figure 10 Package Outlines TQFP-80 for TC22x/TC21x

Note: For the exposed pad of the TQFP-80 package of the TC22x/TC21x, structural corner protrusions have to be considered for purposes of system design and integration with a maximum boundary of 6.2 mm.

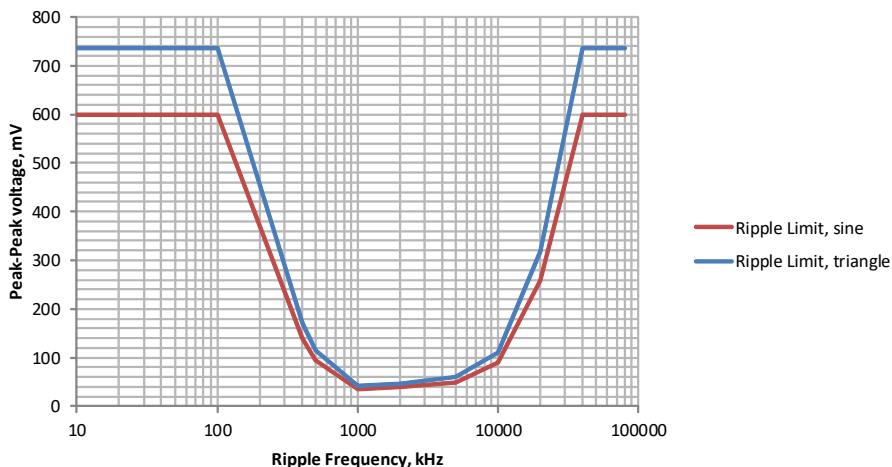
Figure 11 Ripple Voltage vs. Frequency Characteristic

The internal back-up clock is sensitive to specific power supply voltage disturbance/ripple caused by a voltage ripple intrinsic to DC-DC converters. Specific conditions such as insufficient filtering of the ripple may lead to improper behavior of the start-up scheme of the back-up clock, and thus stuck-at state during the start-up of the microcontroller until this condition is removed.

The diagram reflects acceptable ripple level during the cold start of the microcontroller at the respective VDDP3/VEXT/VEVRSB supply of the PMS subsystem, depending on the device and package type, as shown in the following table.

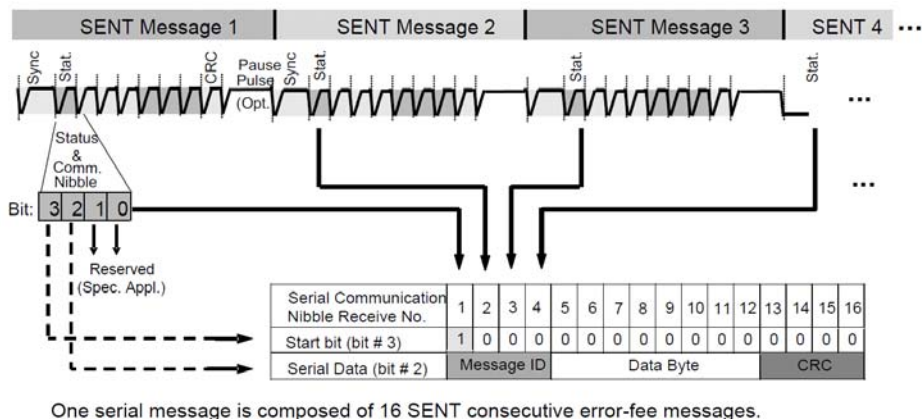
Figure 12 Short Serial Message, Serial Data Encoding over 16 messages

Figure 12 shows a corrected version of this figure.
