Device TC22x/TC21x
Marking/Step ES-AC, AC
Package see Data Sheet

10310AERRA

This Errata Sheet describes the deviations from the current user documentation.

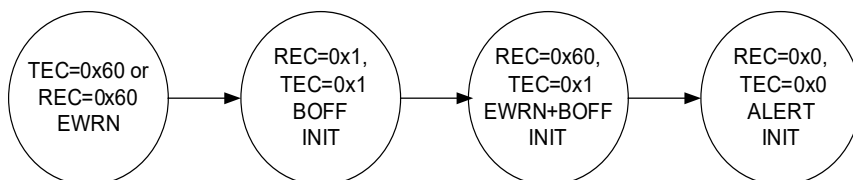
Figure 4 Alert Interrupt Behavior in case of Bus-Off

When the threshold for error warning (EWRN) is reached (default value of Error Warning Level EWRN = 0x60), then the EWRN interrupt is issued. The bus-off (BOFF) status is reached if $TEC > 255$ according to CAN specification, changing the MultiCAN module with REC and TEC to the same value 0x1, setting the INIT bit to 1_B, and issuing the BOFF interrupt. The bus-off recovery phase starts automatically. Every time an idle time is seen, REC is incremented. If REC = 0x60, a combined status EWRN+BOFF is reached. The corresponding interrupt can also be seen as a pre-warning interrupt, that the bus-off recovery
